**ELECTRONICS COORDINATING OF**  
**SHIP PREPARATION**  
**and**  
**TARGET INSPECTION**

**FINAL REPORT**  
**TESTS ABLE AND BAKER**

**VOLUME 2**  
**PHOTOGRAPHIC RECORD**

**DIRECTOR OF SHIP MATERIAL**  
**JOINT TASK FORCE ONE**  
**OPERATION CROSSROADS**

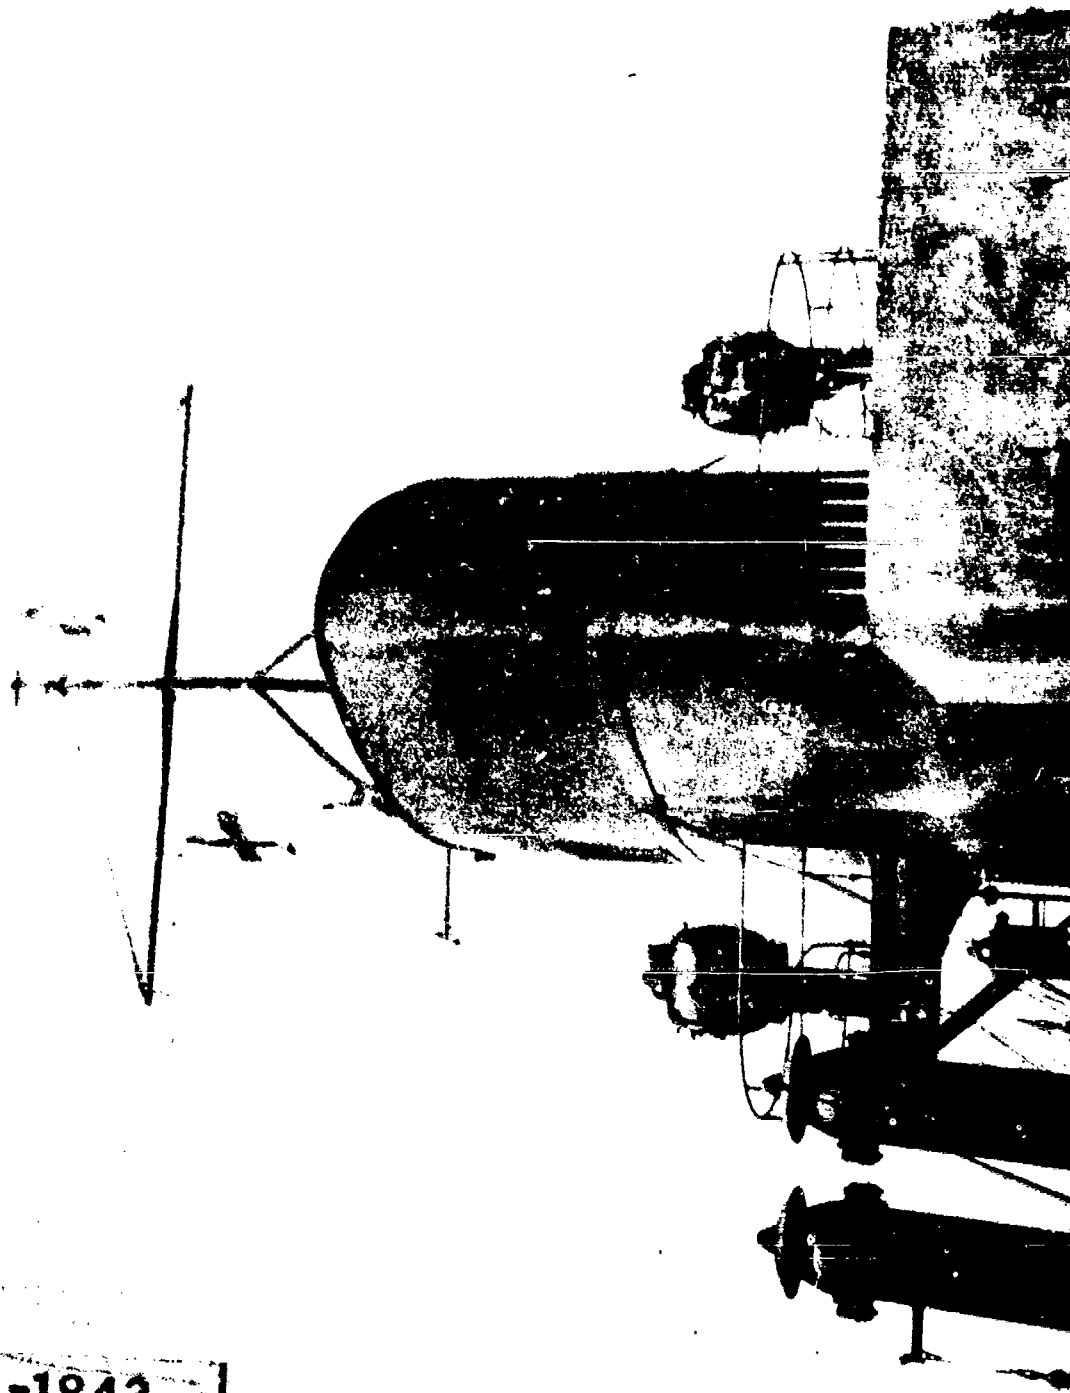
POST ABLE - FOREMAST AND ANTENNA TRUNKS. Radiator of TBS antenna at top of foremast was bent. In left foreground are two radio antenna trunks from which antennas have been torn. Note arrows indicating broken strain insulators.

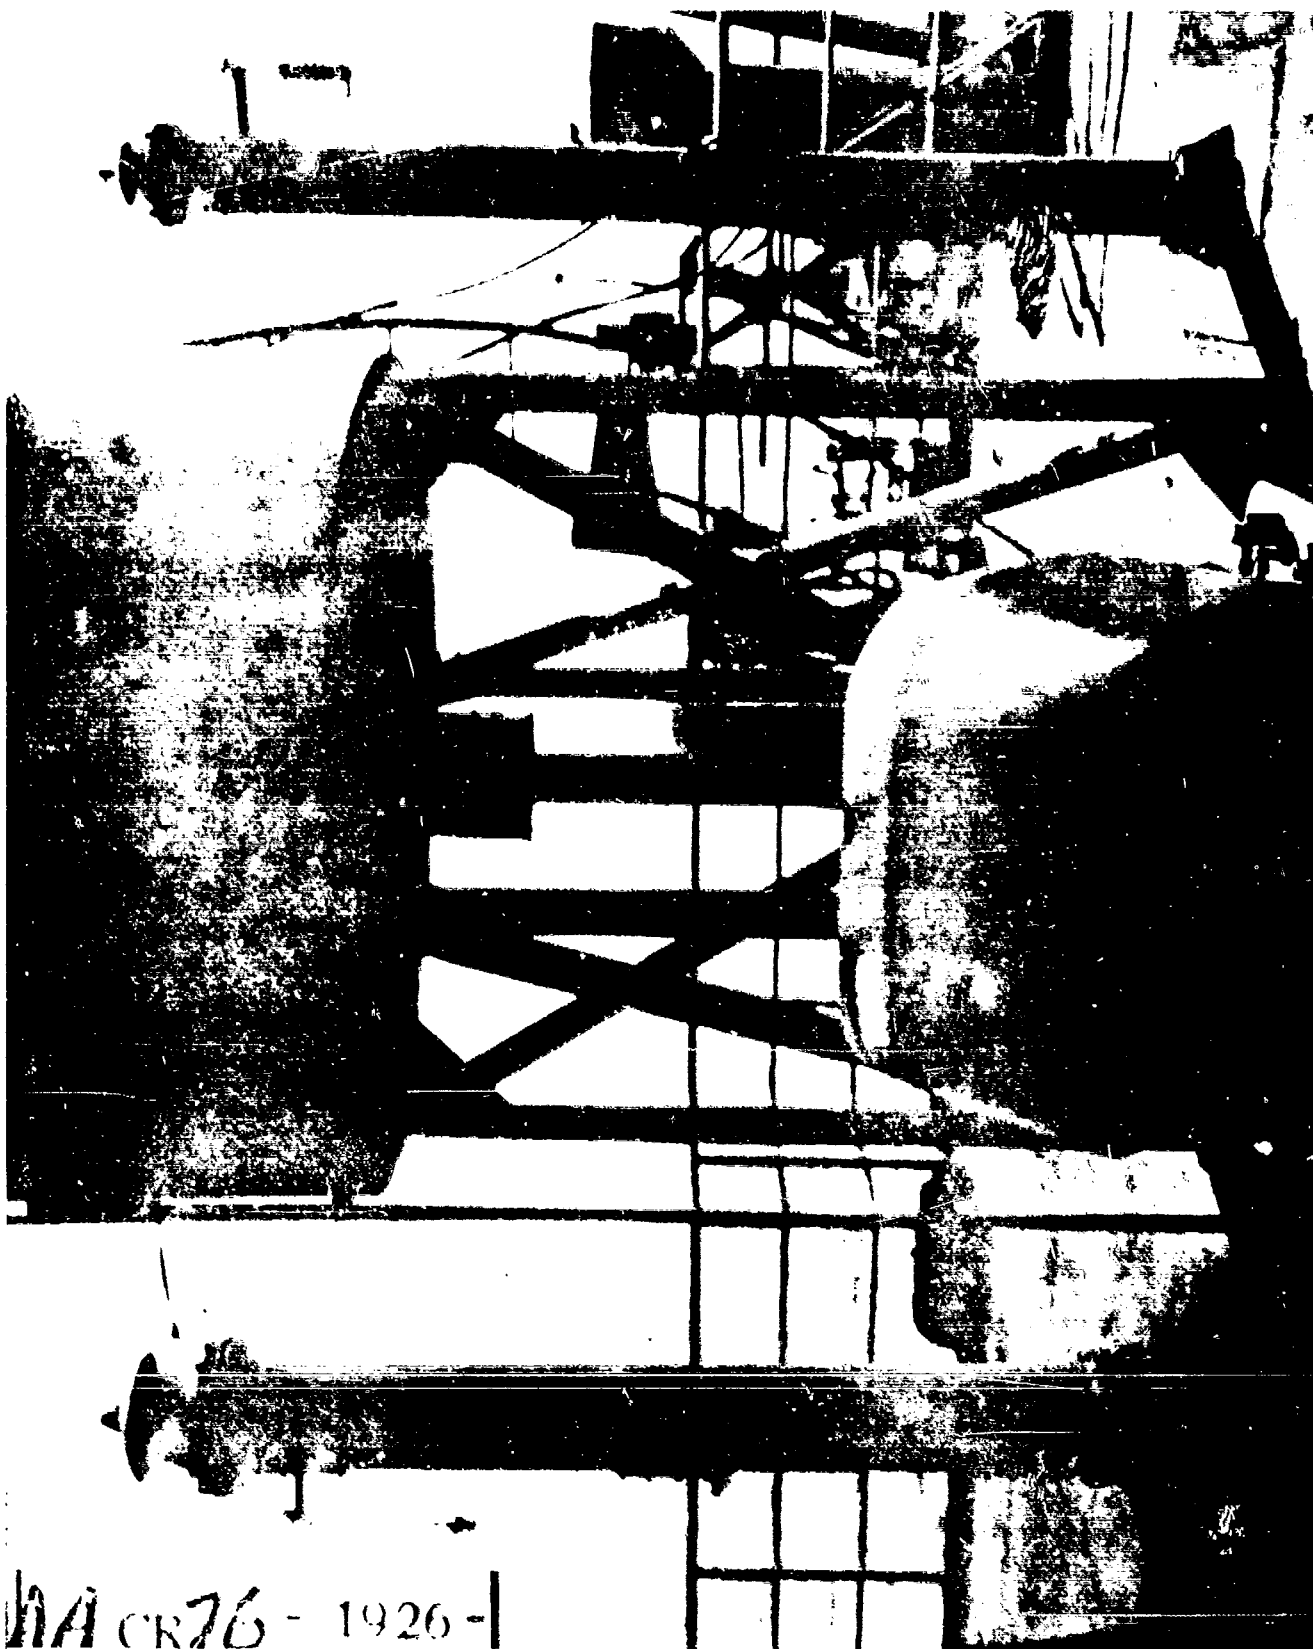
POST ABLE - EMERGENCY RADIO TRUNKS. Typical case of antenna damage,  
with broken strain insulator and wires.

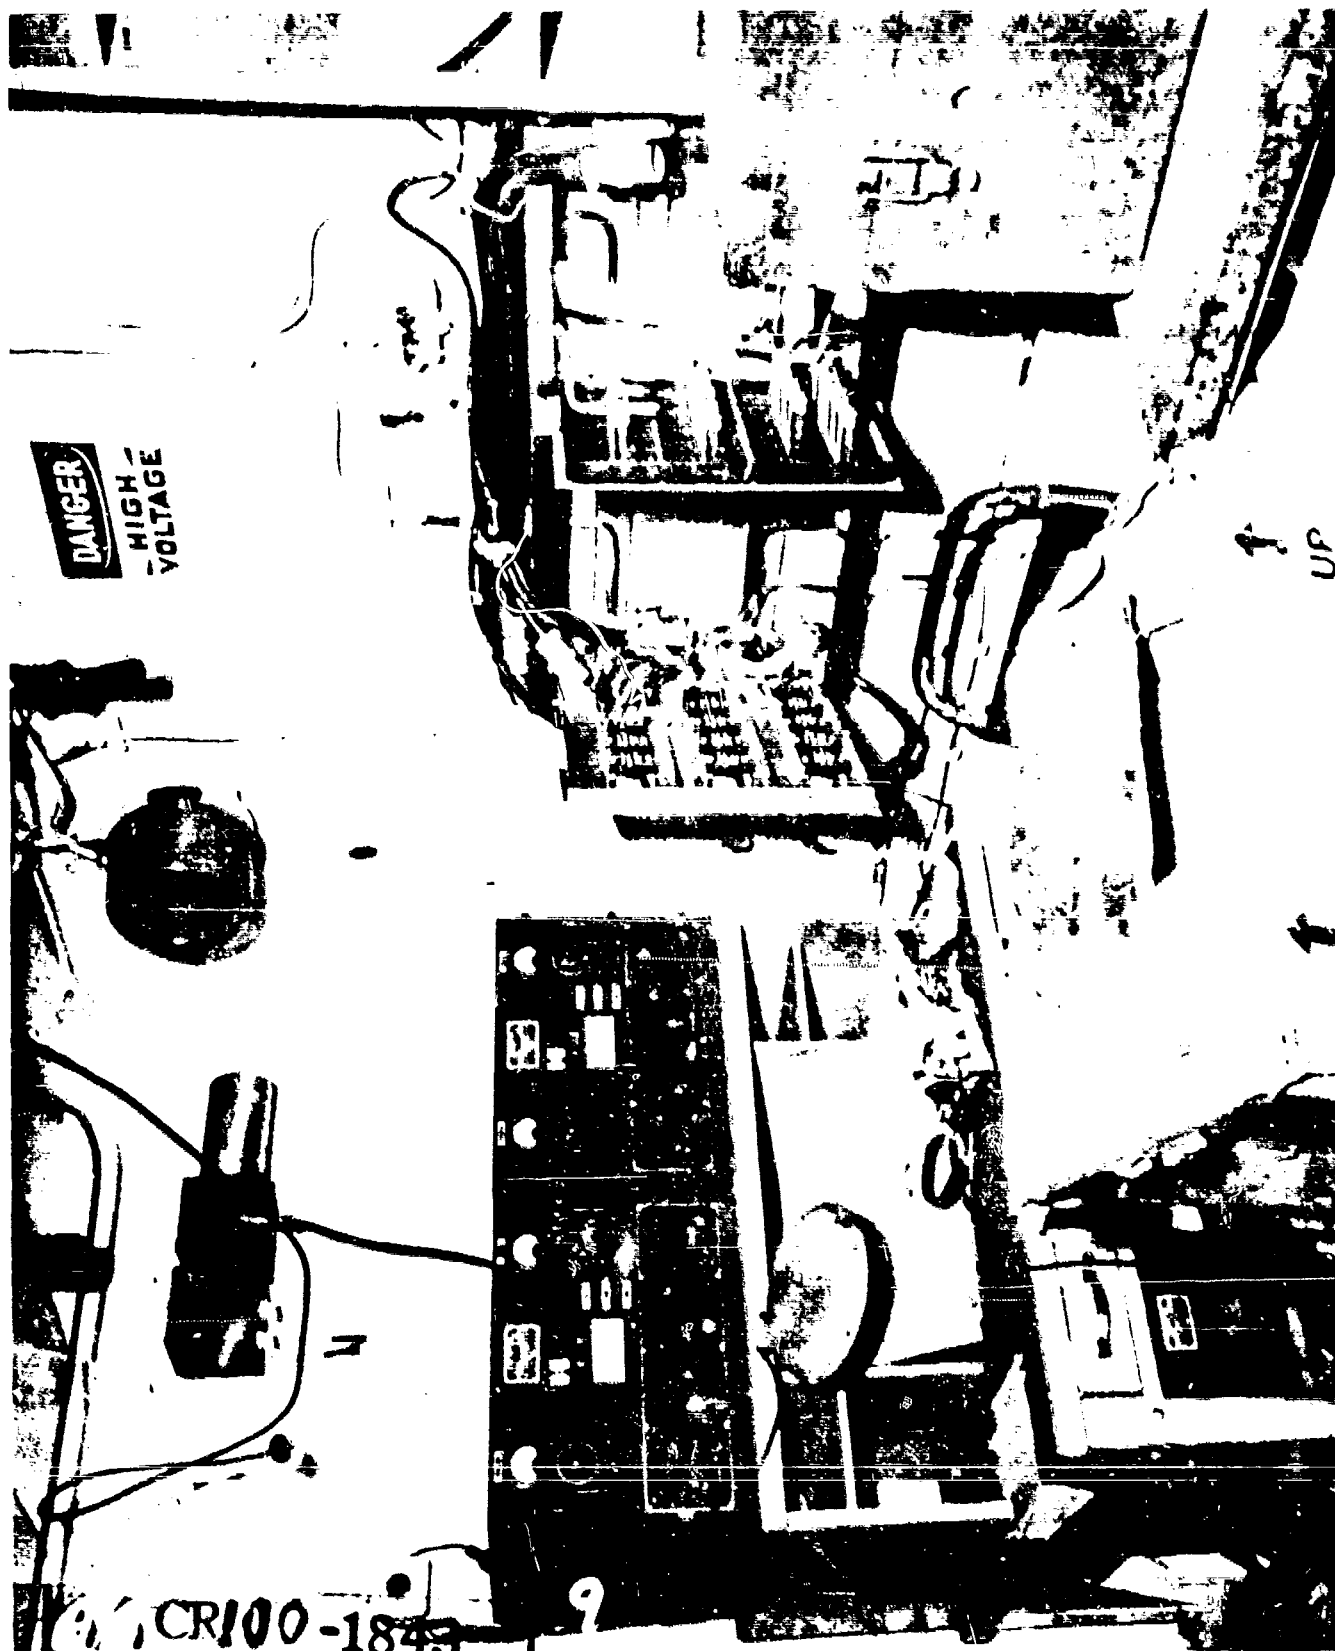
POST ABLE - RADIO III. The patch panel was opened by shock but caused no damage.

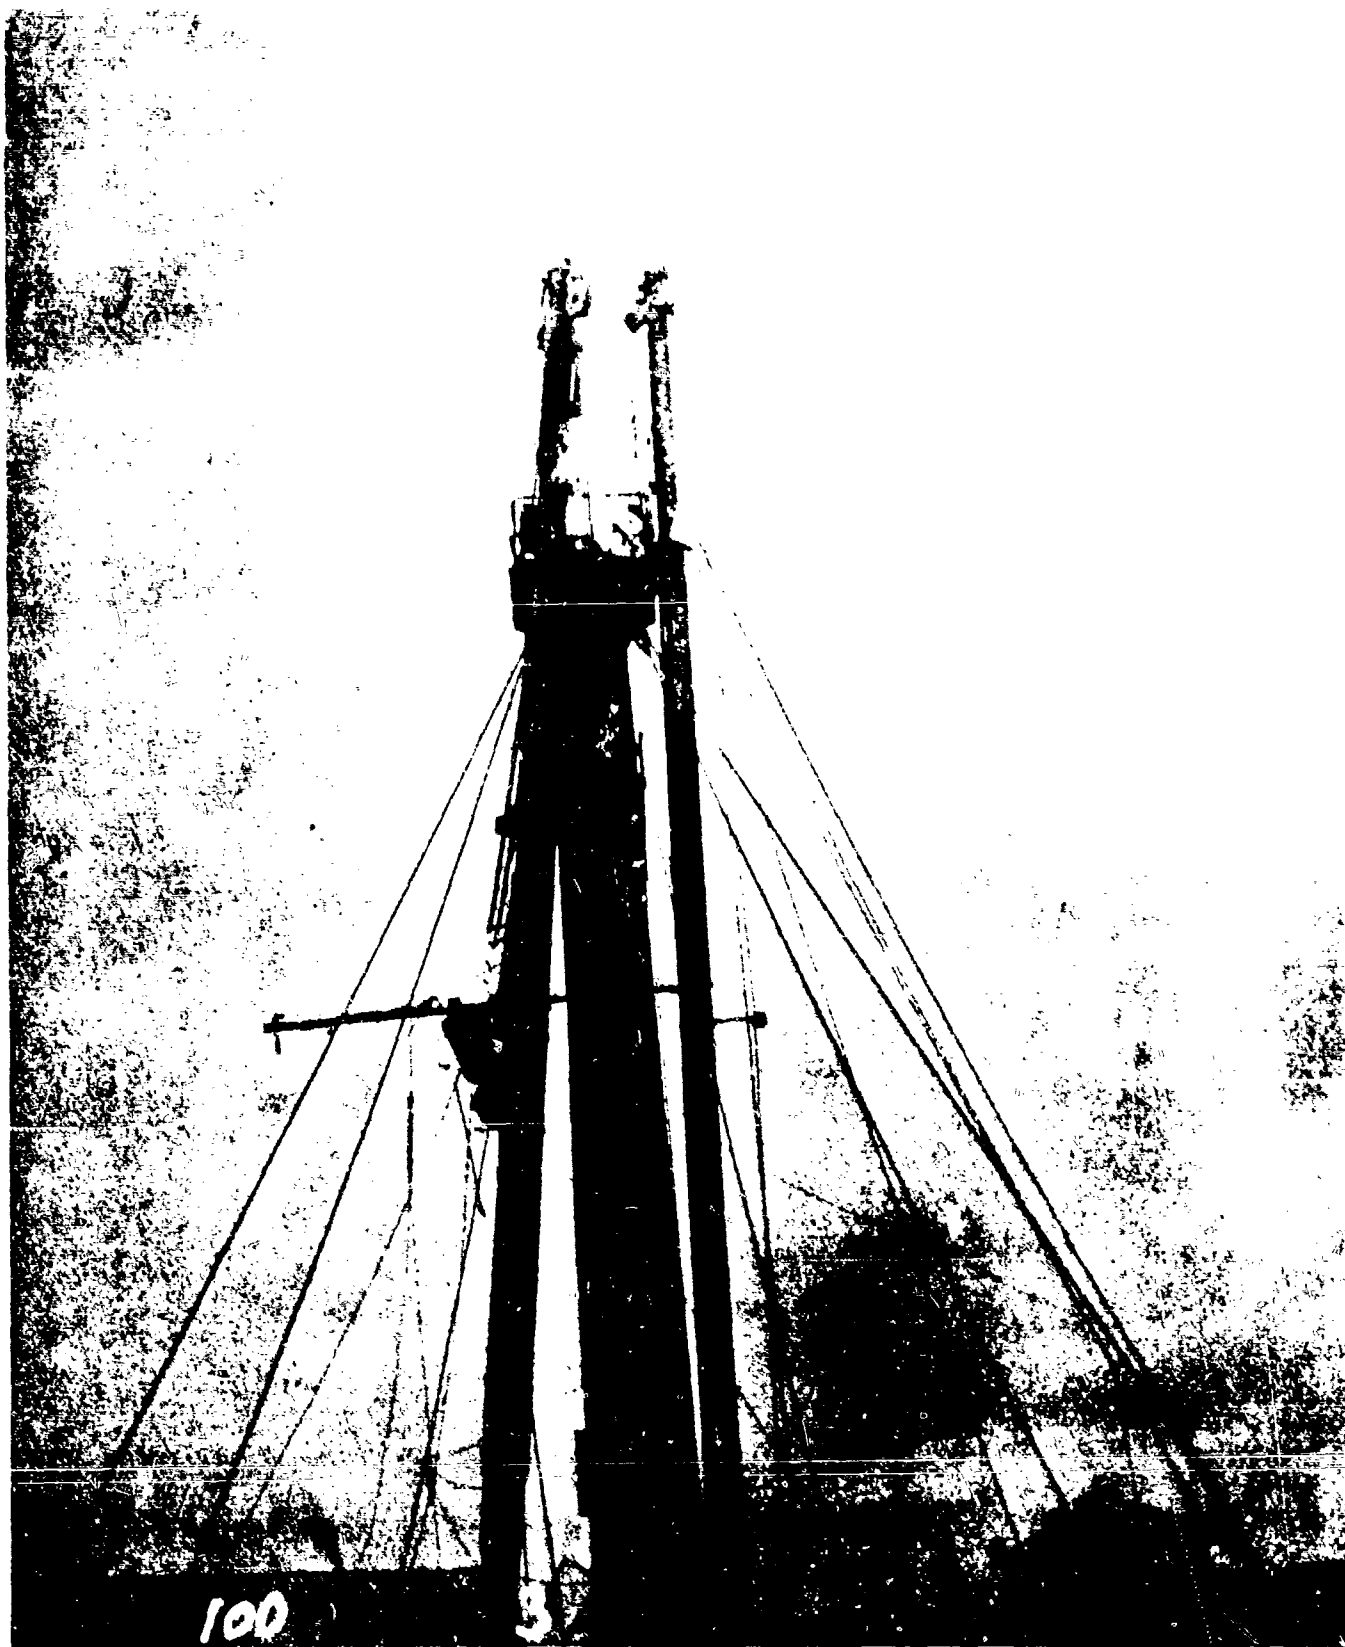
POST ABLE - MAINMAST. Upper section looking aft.

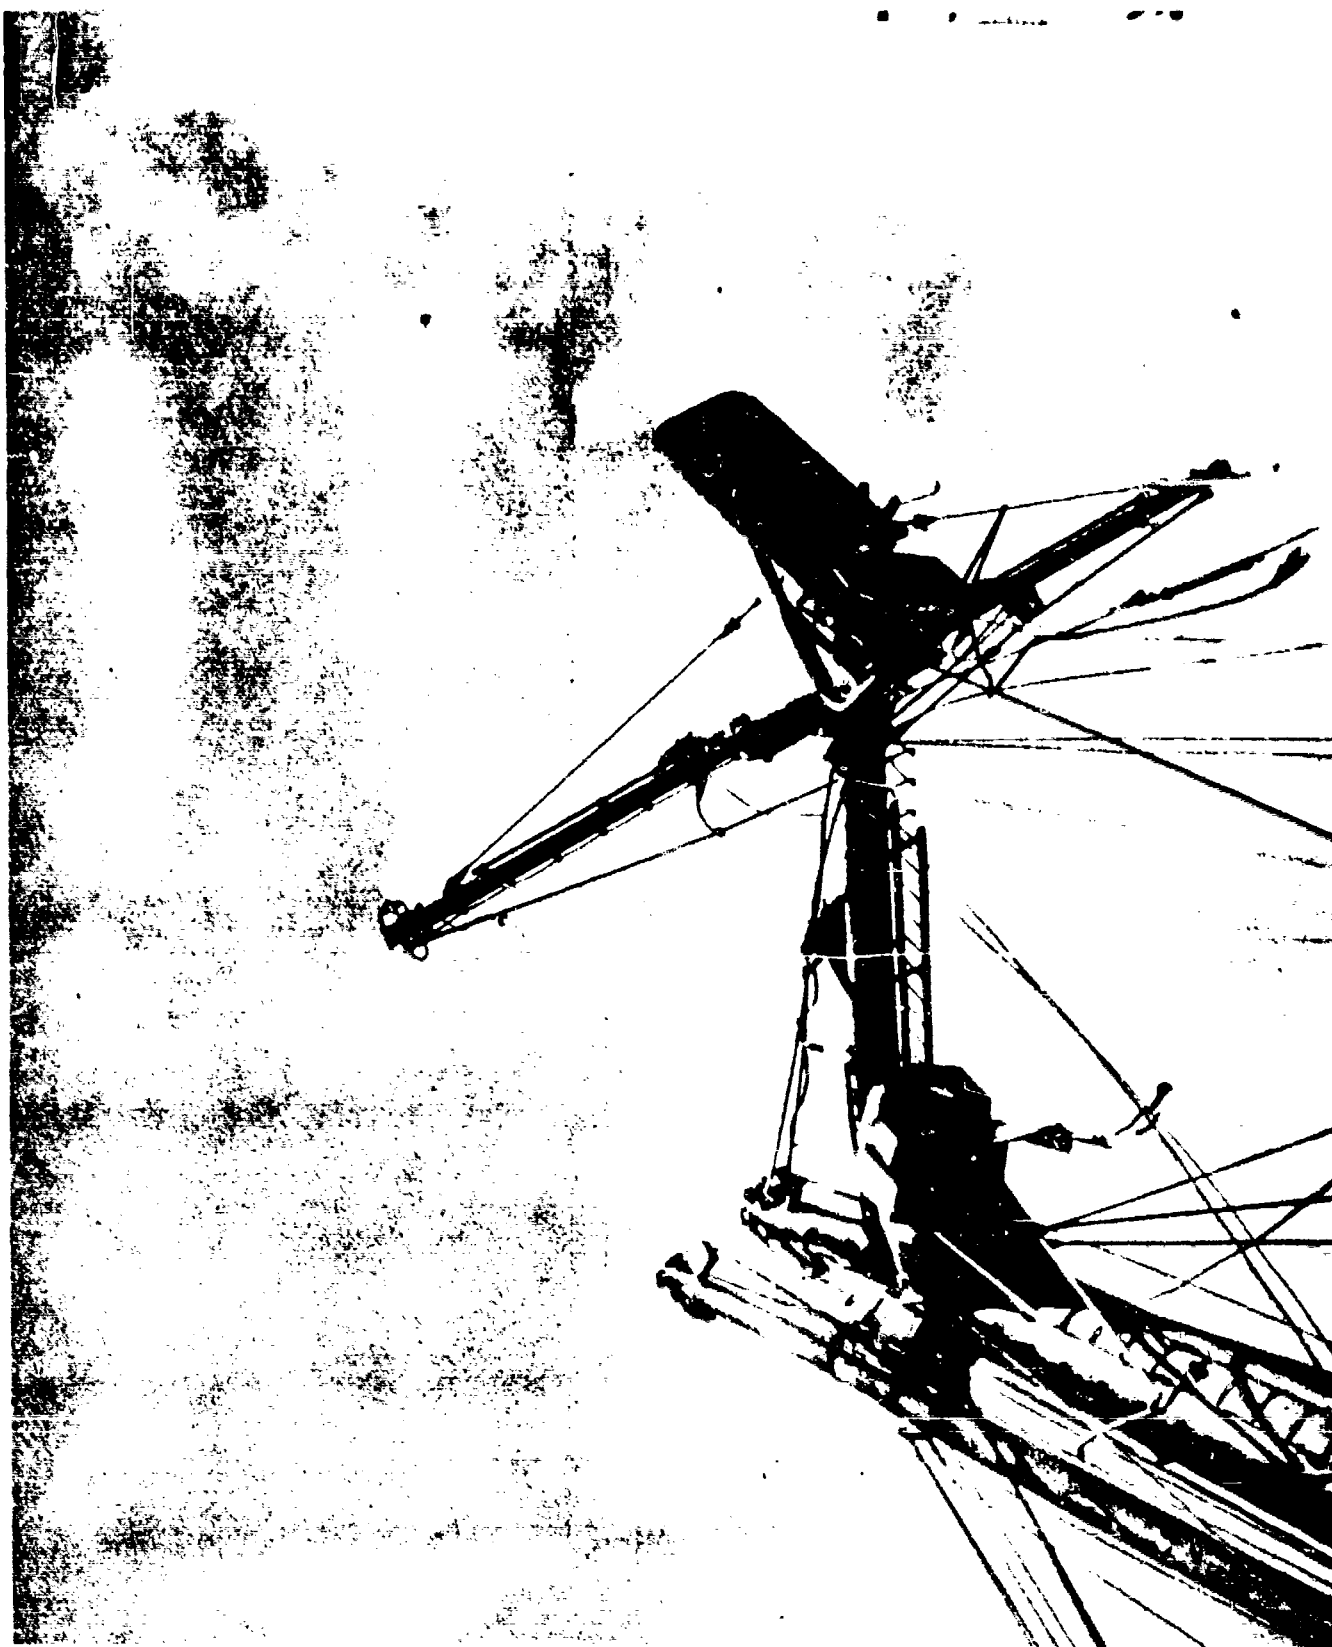
POST ABLE - MAINMAST. Top section blown over. Base ring of SC-4 pedestal still bolted to foundation, with a few fragments of pedestal remaining.

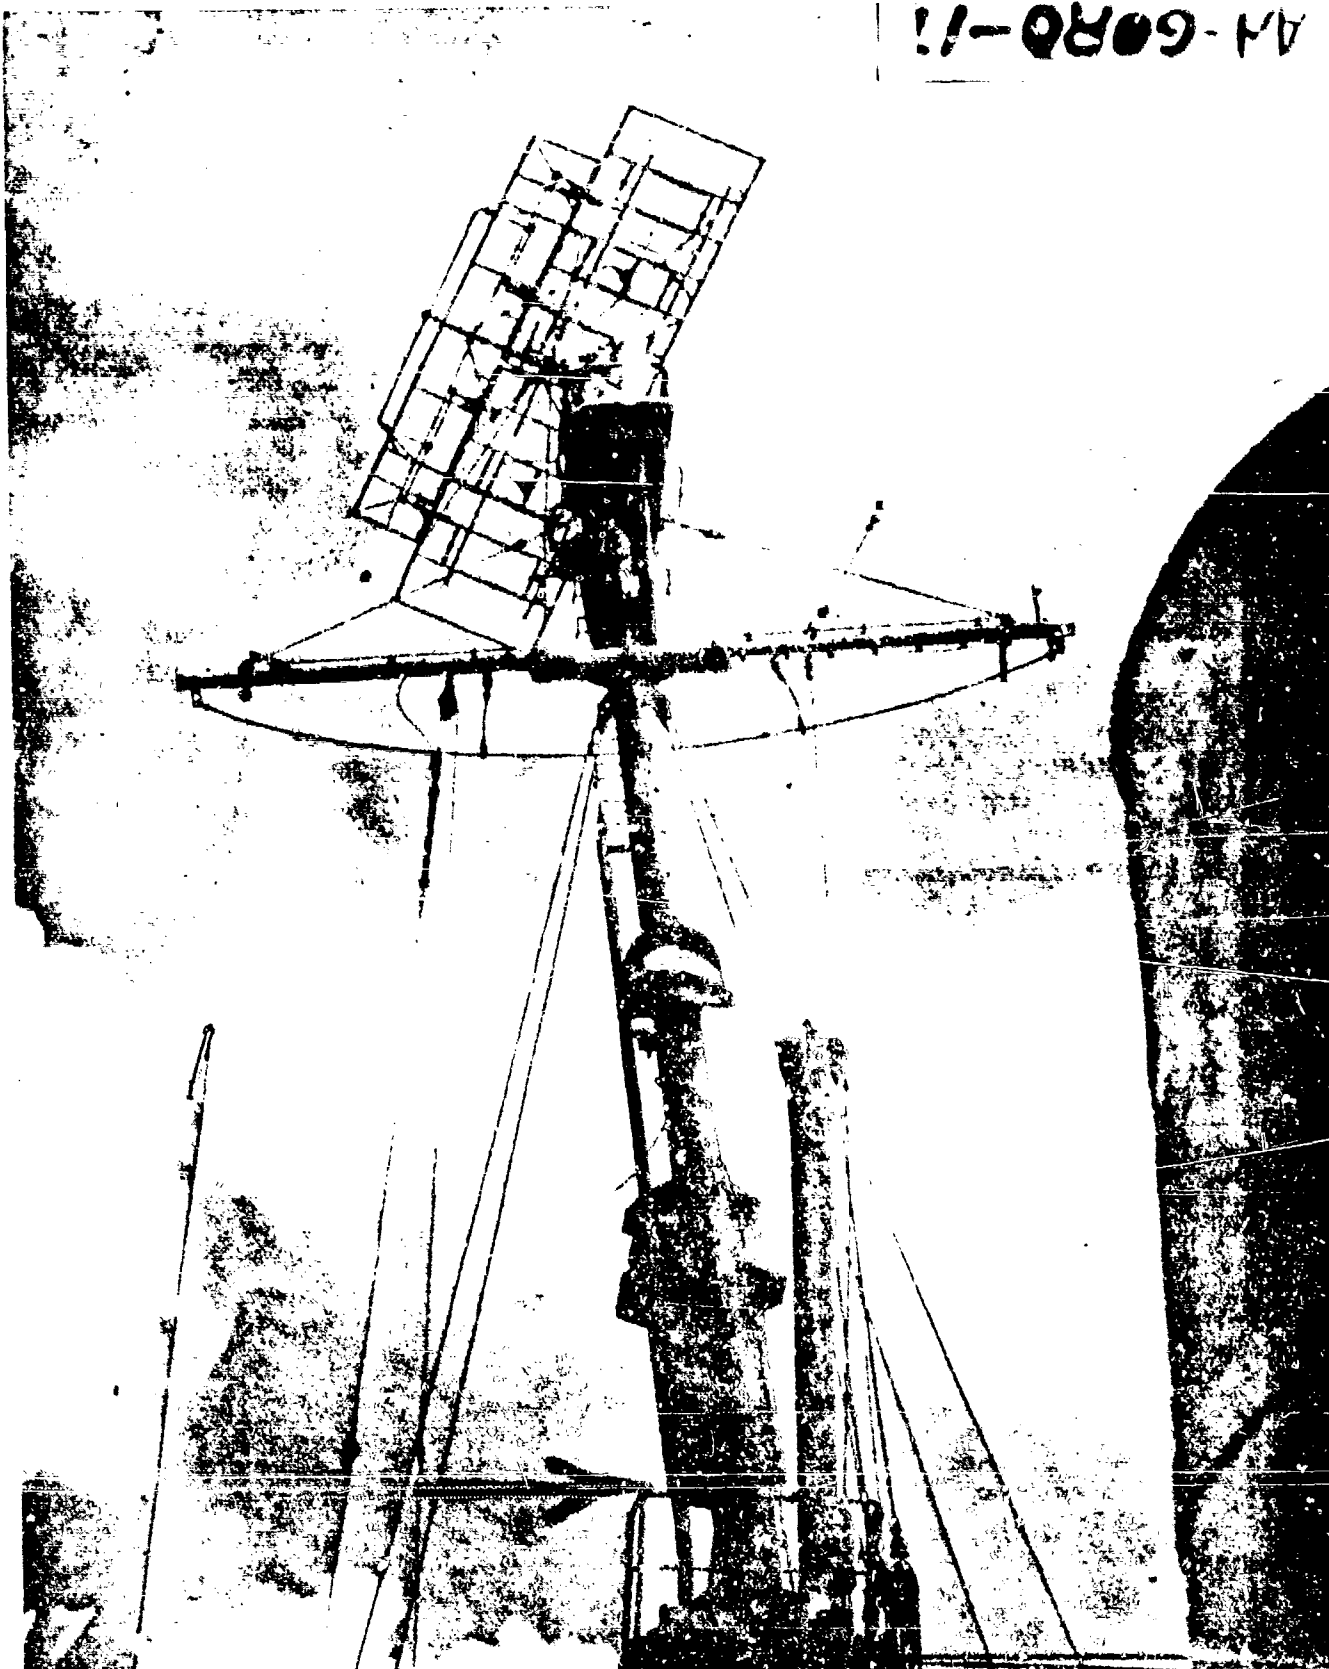
POST ABLE - SC ANTENNA. Mainmast was bent, (see arrow) and SC antenna was tilted by blast.

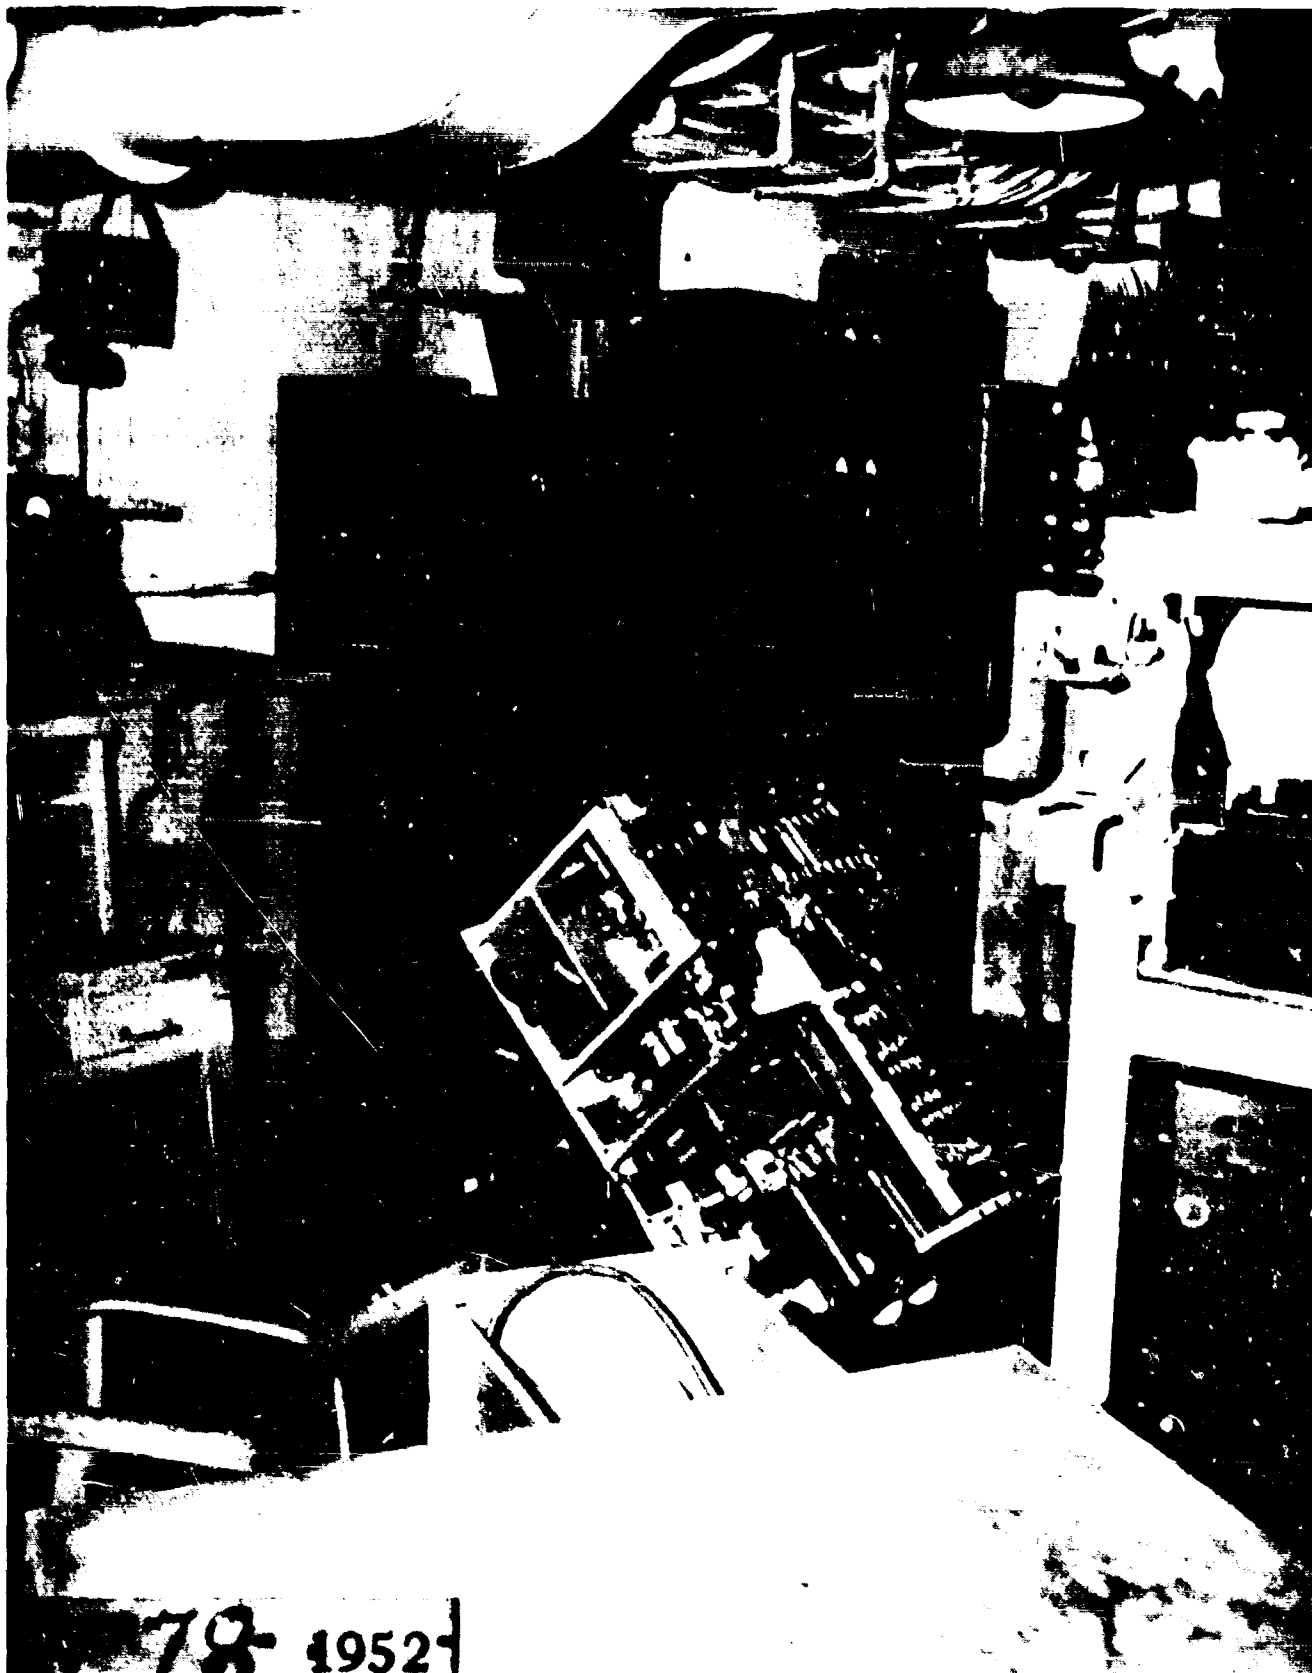
POST BAKER - TDE. TDE was pulled out of its case and fell to the deck. The method of securing this equipment in its case was inadequate to withstand the shock.

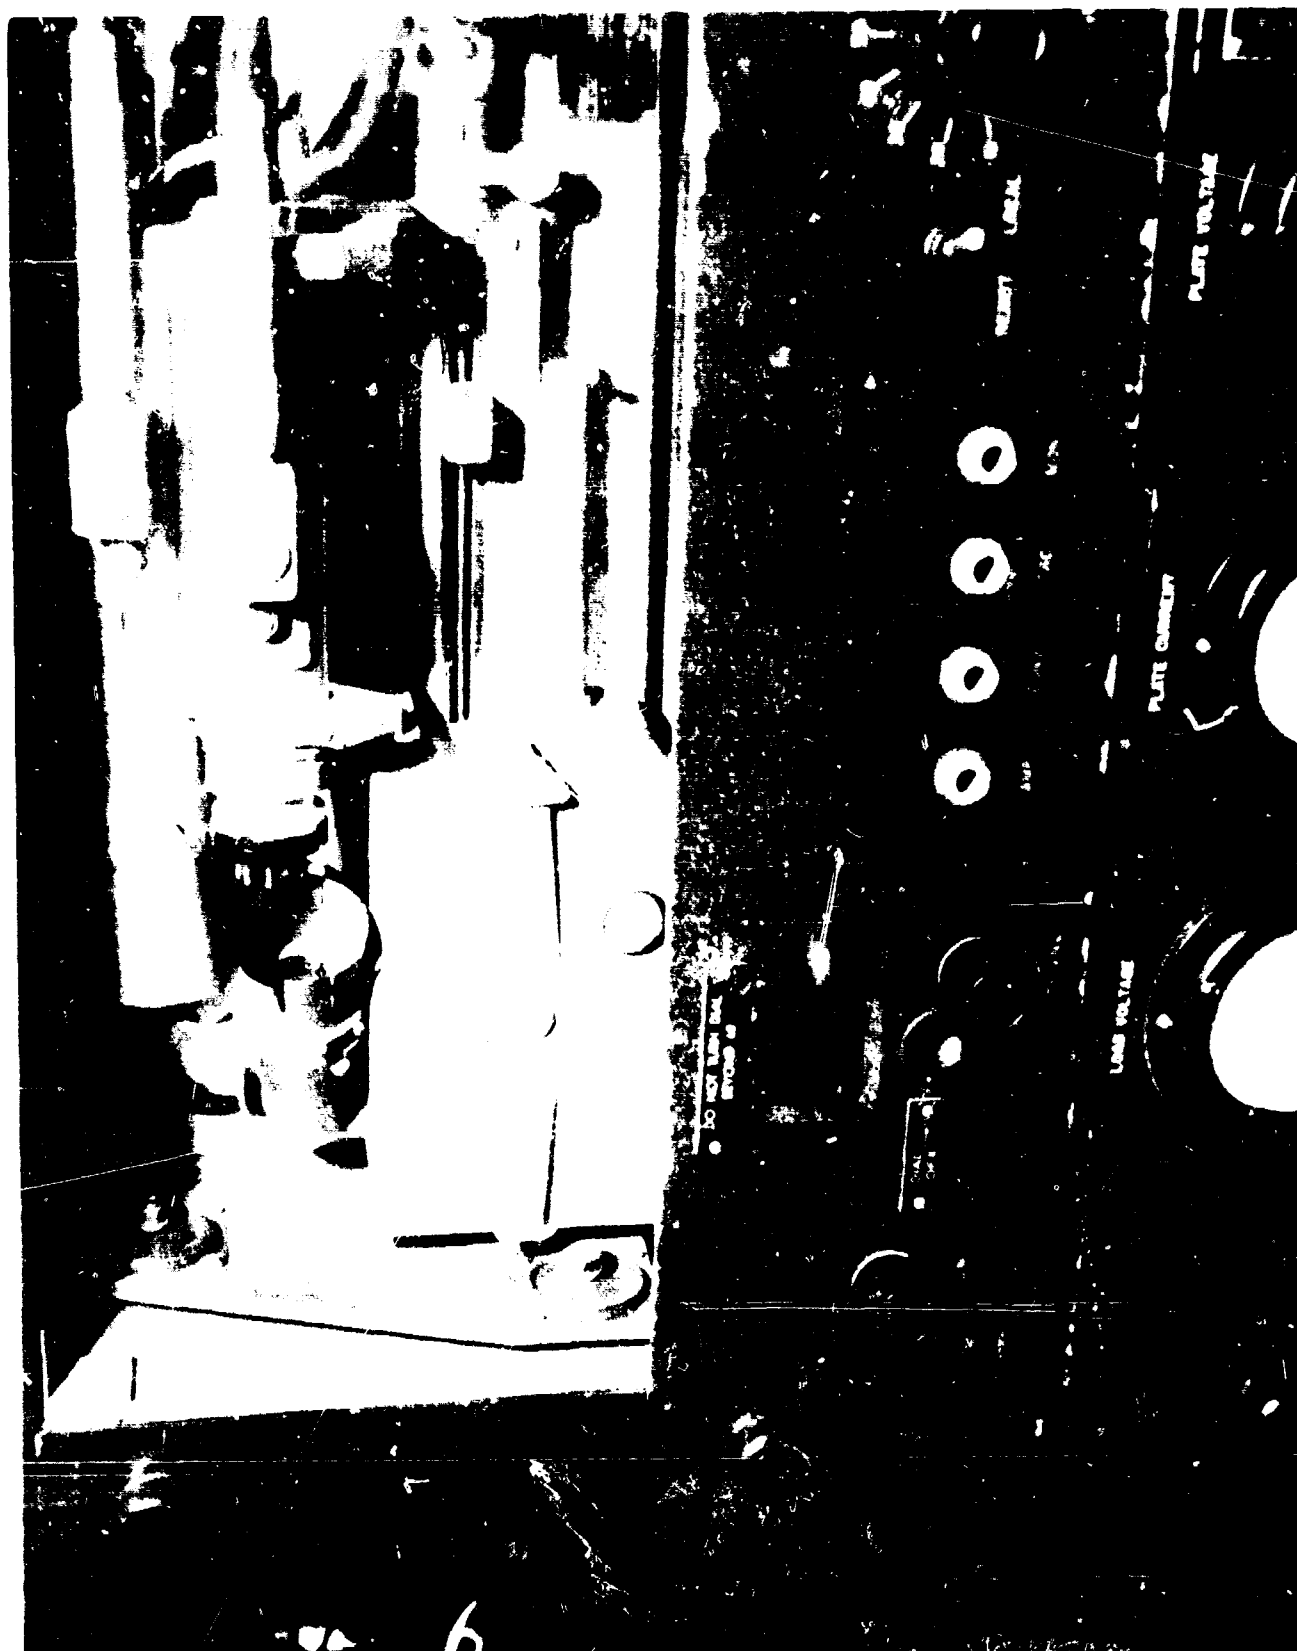
POST BAKER - FORWARD MK 4 RADAR RF AMPLIFIER UNIT. Socket was knocked off and bent. This main frame was not shock mounted.

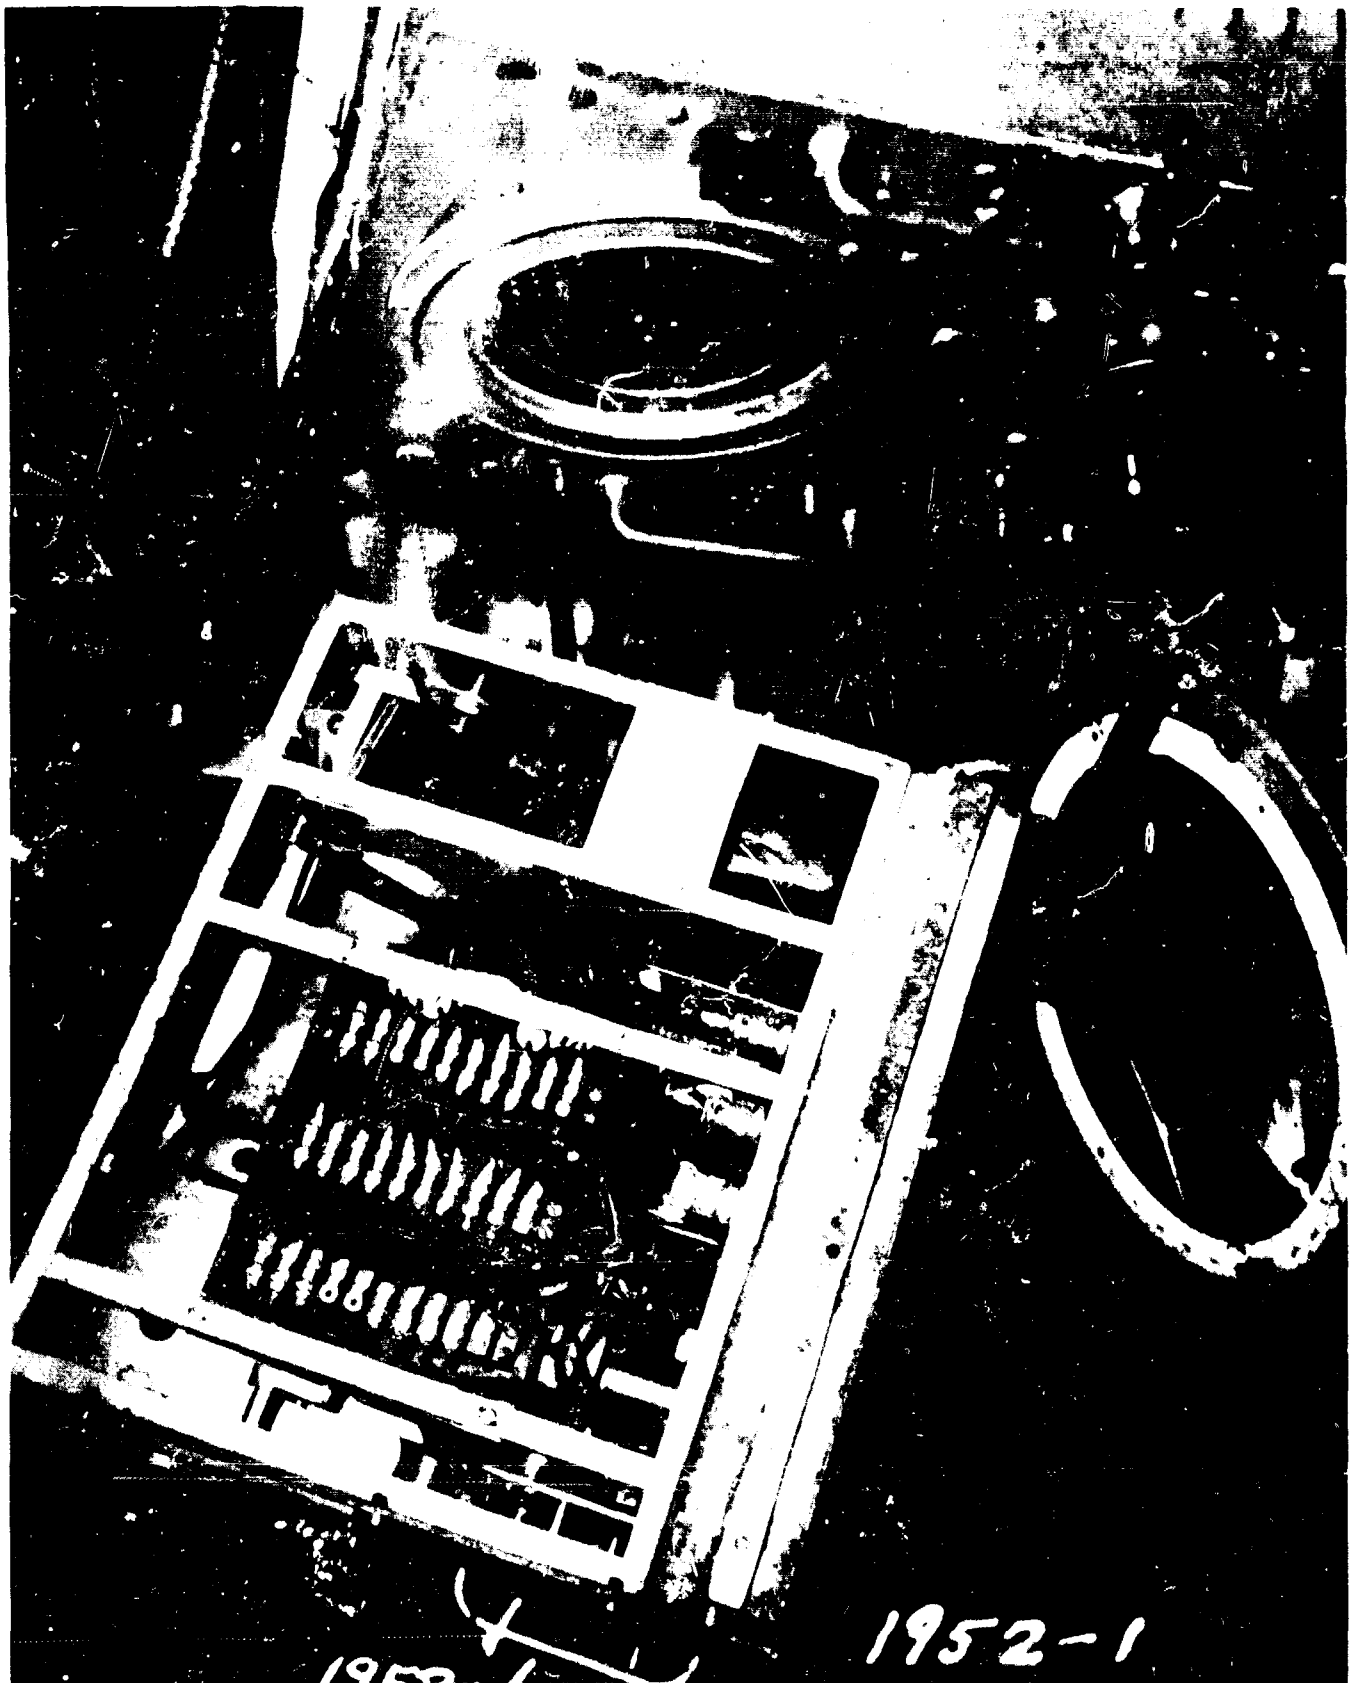
POST BAKER - SC CONSOLE. The entire console was moved about 8 feet. The indicator was thrown out and was left hanging from its cables.

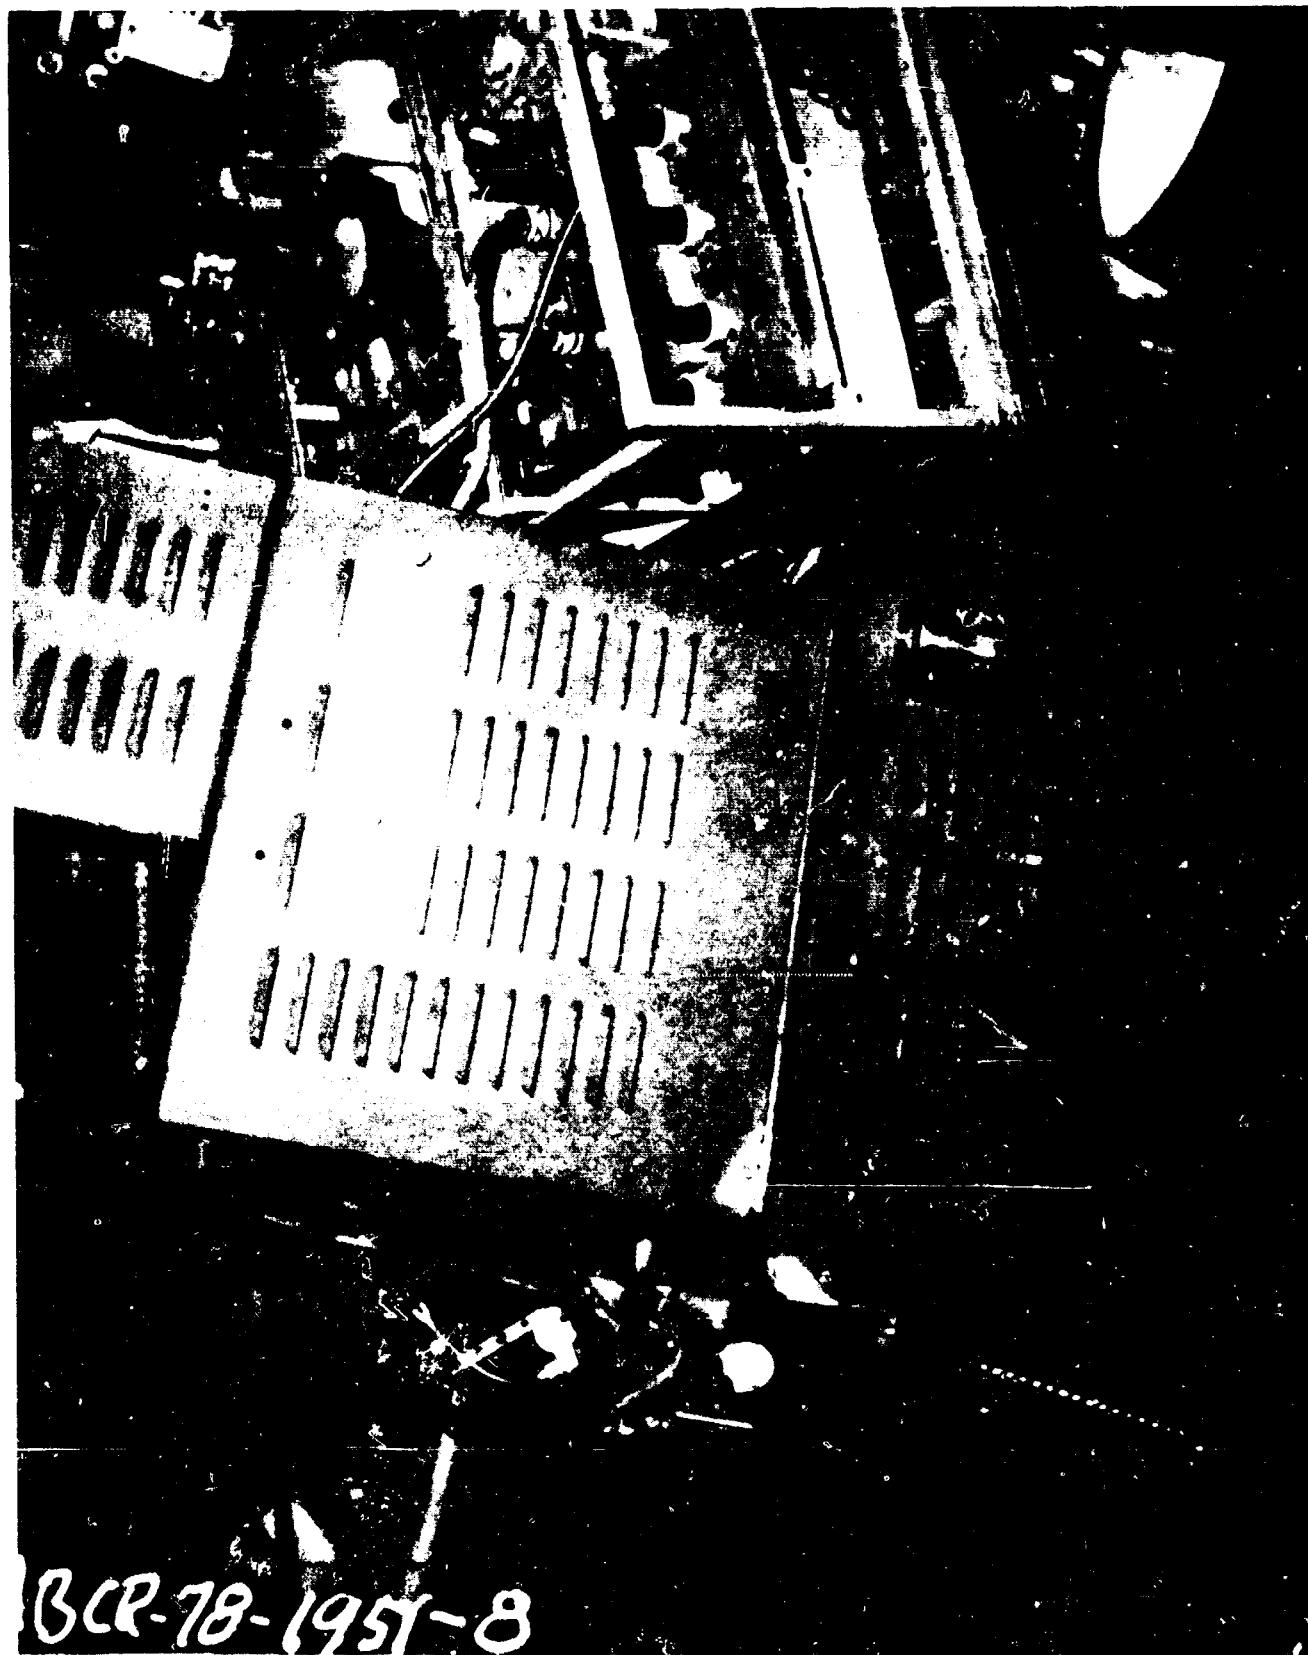
POST BAKER- SC CONSOLE. Top view showing the indicator on the right.
